Restaurant Environment and Its Possible Effects on Food Safety: Case Study of Restaurants in Palestinian Ramallah-Bireh District

*Issam A. Al-Khatib*¹ and Suzan M. Al-Mitwalli¹*

(J Med J 2007; Vol. 41 (3): 145- 152)

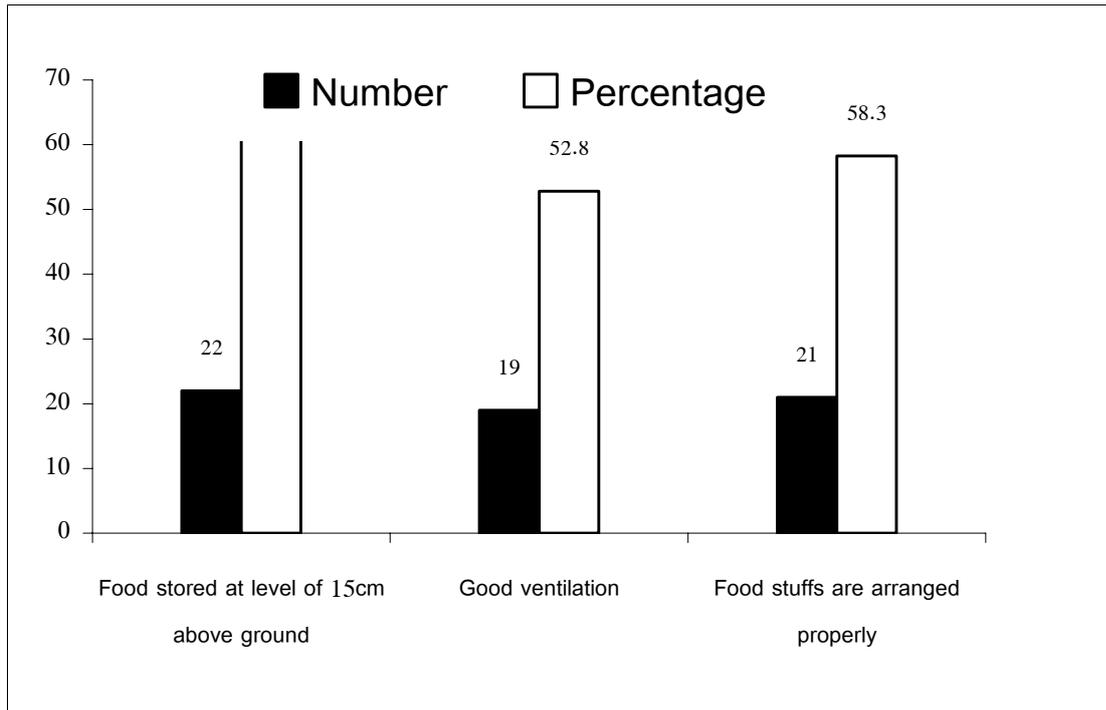
Figure 1: Number and percentage of restaurants that satisfy some necessary storage conditions.

* Note: the percentage in this table is out of 37 restaurants that have a storage area.

Storage of Foodstuffs and Cleaning Materials: Out of the 202 restaurants surveyed, only 37 (18.3%) restaurants have a special store for foodstuffs. Of those few restaurants that have a storage room, many do not satisfy the conditions specified for storage, as shown in figure (1). It was found that 93.3% of the restaurants have cleaning materials for their equipment, utensils and floors, but only 75.4% of the restaurants store the cleaning materials in a proper way.
